# **Detection of service pipes and the risk of collapsing sinkholes at the Lake of Constance in Switzerland using Ground Penetrating Radar (GPR)**

**Edi MEIER, Inma GUTIÉRREZ, Marco BAUMANN, Max BOSSHARD and Rainer HEEB, Switzerland**

## **SUMMARY**

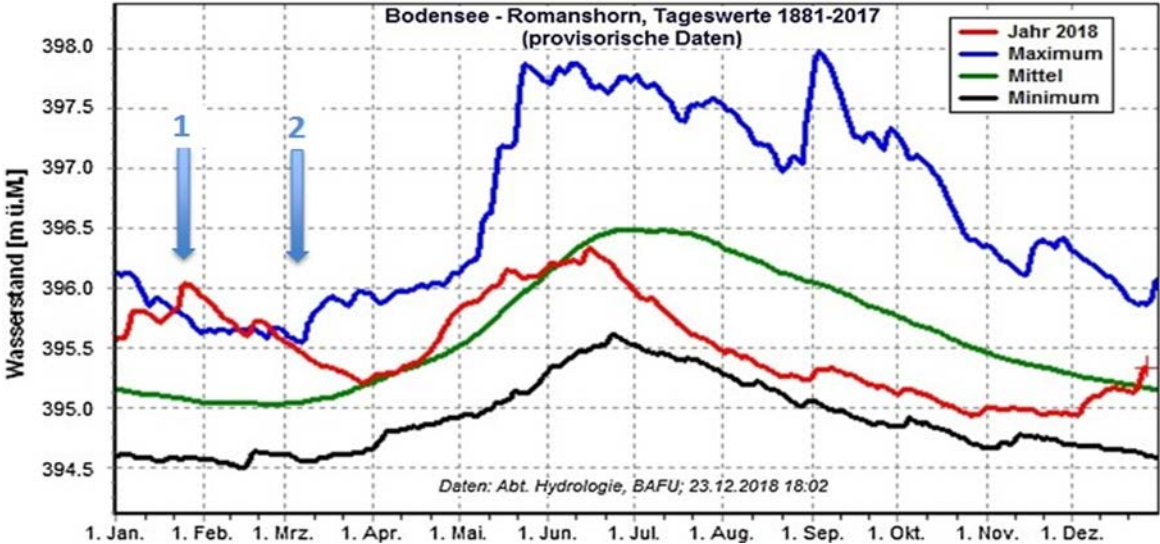
**Fig. 2):** Water level fluctuation of the Lake Constance since 1881. Red curve = curve for the year 2018, green curve = mean water level, black curve = min. water level, blue curve = max. water level.

During winter 2018 extreme climatic conditions prevailed in the area of the Lake Constance. At the beginning of February the lake water level was higher than the since 1881 measured data (Fig. 2). Driven by a strong north wind big waves lashed to the shore of the promenade. With temperatures below zero the whole area was covered by a dangerous ice shield (Fig. 3 left).

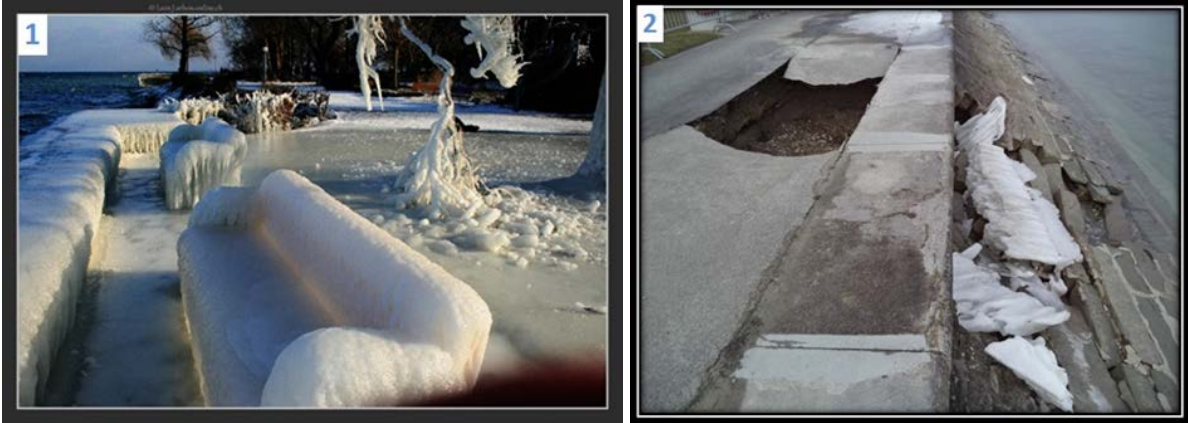
**Fig. 3):** Ice shield on the shore in February (left) [4]. Collapsed ground after the melting of the ice in March 2018 (right).

One month later, when the ice melted away, the ground under the fairground plaza and under the pedestrian promenade suddenly collapsed (Fig. 3 right). Only the massive retaining wall did not tumble down and formed a bridge (Fig. 4 left). Apparently, the poor condition of the shore ramp and the high water level - in combination with the strong north wind - was the cause for the soil erosion. The lakewater could penetrate through openings and cracks in the wall (Fig. 4 right) and loosened the ground when freezing.

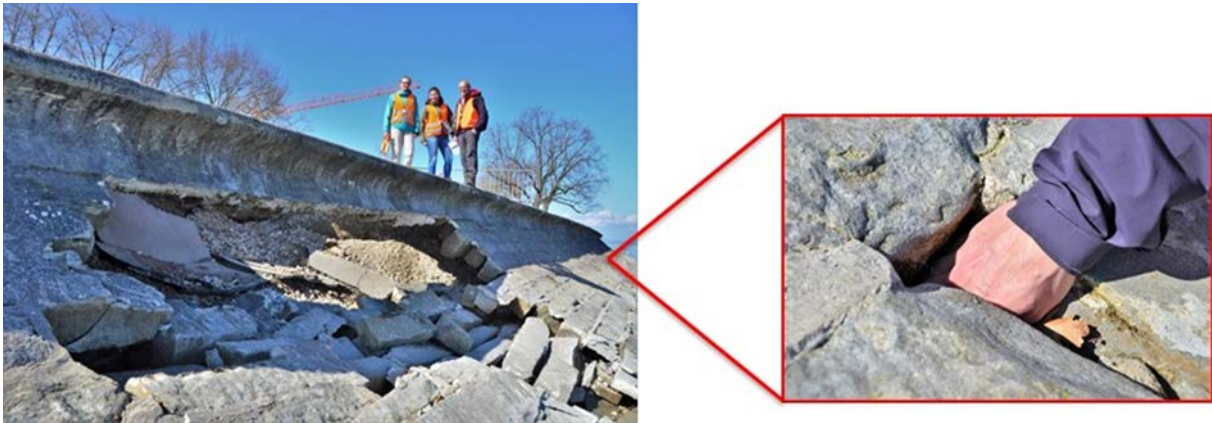
**Fig. 4):** Collapsed site near the promenade (left). Holes between the stones in the ramp (right).

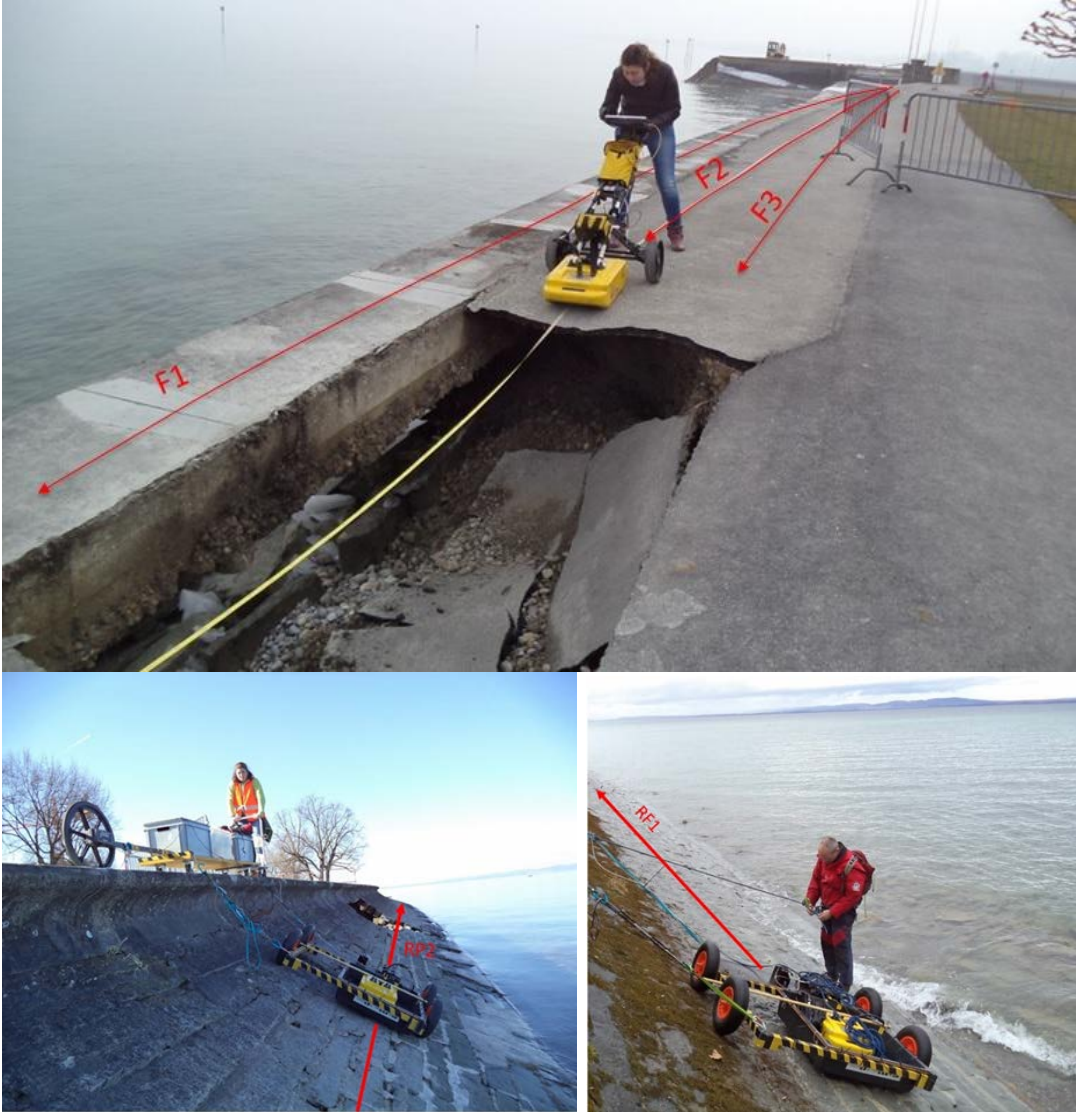
**Fig. 5):** GPR shots along the promenade: Three profiles on top of the path, view towards the fairground plaza (top picture), two profiles on the ramp wall, view in the opposite direction (pictures below).

Two areas were investigated: the pedestrian walkway and the fairground plaza, both with associated ramp. The measured data were collected in five parallel rows. During the first measurements, there were still a few icy places on the shore. A GPR system with shielded 250- / 700-MHz double antennas was used (Fig. 5 above).

A week later the two profiles on the shore ramp were executed. For this purpose, two carriages were built, a guiding carriage for the quay wall and a carriage for the ramp wall. They were fixed together with a rope-system.

The guiding carriage was equipped with a precision trigger wheel. This released a measurement every 5 cm interval. The carriage with the radar antenna on the ramp wall was pulled with the same speed as the guiding carriage. Thus, the metering of the ramp profiles is always comparable to that of the profile F1 on the quay wall.

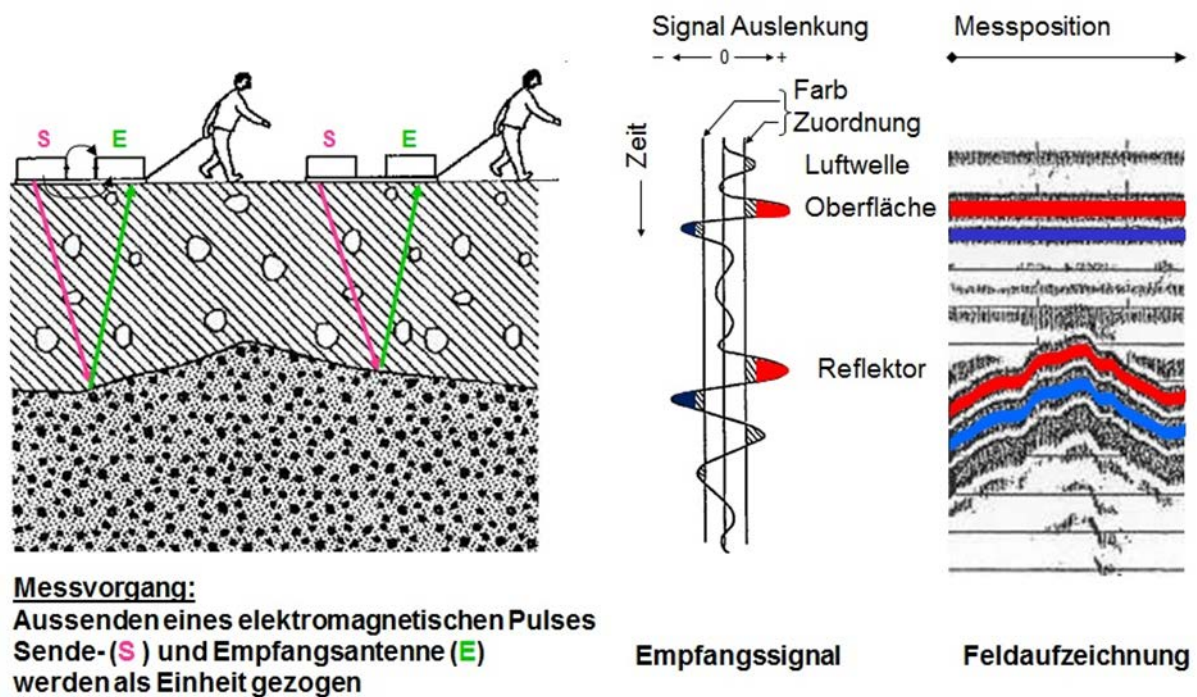
Fig. 6): Principle of GPR measurement (Meier E. et al., 2002)

A radar pulse is emitted from the transmission antenna into the ground, which is reflected at interfaces of rock packages or layers in the underground (Fig. 6). Thereafter, the pulse returns to the receiving antenna where it is recorded. The time that elapsed between transmission and reception of the pulse provides information about the depth of the object (reflector). The strength of a reflection serves as a clue to the electrical properties of the material that caused the reflection.

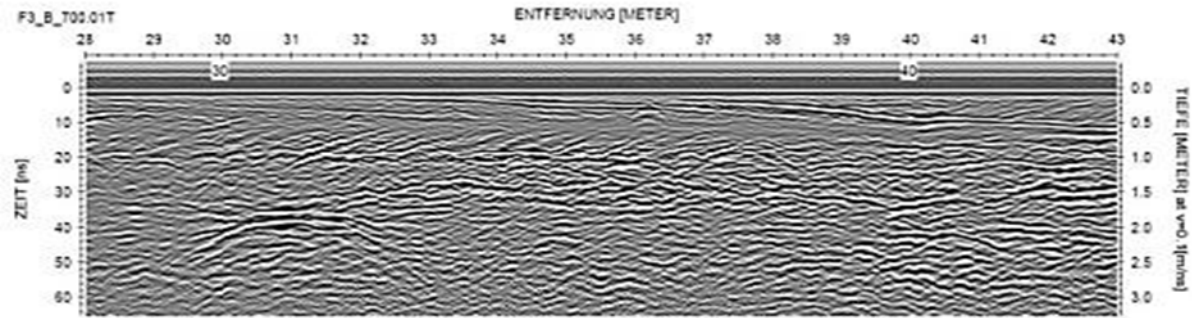
**Fig. 7):** Part of profile F3, taken with the 700 MHz antenna.

On both pictures is the same structure clearly visible: a structure up to 1 m depth, that slopes to the left, is seen on the left half on the “radargram” as well as the departure tracks of the construction machines on the right half.

The “radargrams” recorded on the pedestrian path show clear structures up to about 4 m depth. Profile F3 was taken at a distance of 2 meters parallel to the quay wall. Figures 7 and 8 show the same section as profile F3, but were recorded with two different frequencies. While the 700 MHz antenna shows smaller structures (Fig. 7), the 250 MHz antenna achieves greater depth penetration (Fig. 8).

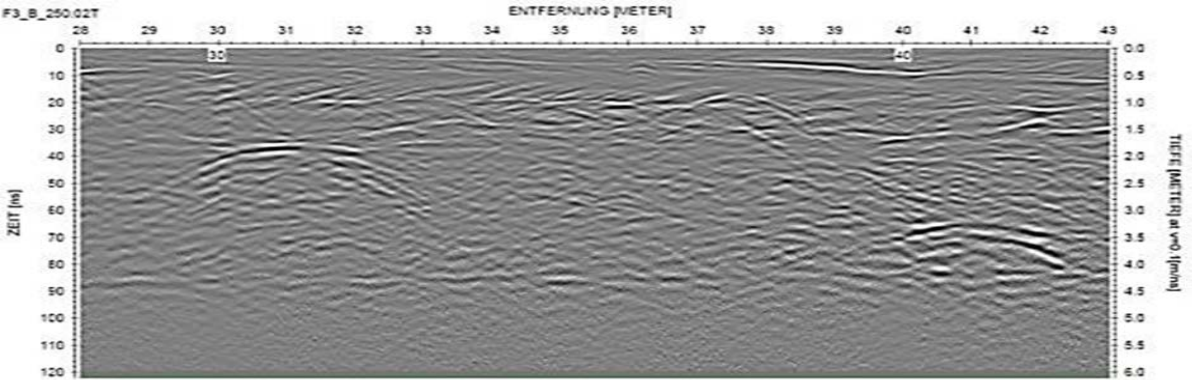
**Fig. 8):** Part of profile F3, taken with the 250 MHz antenna.

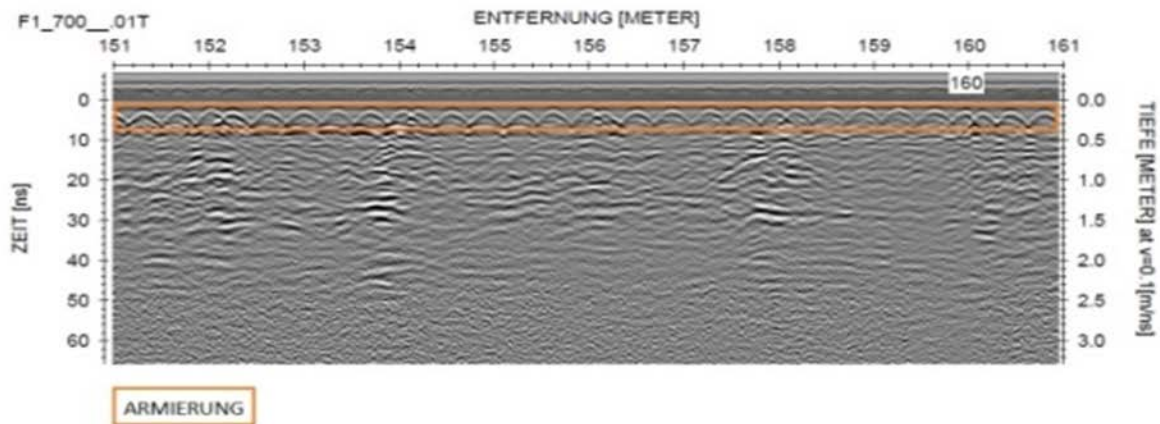
**Fig. 9)** Part of profile F1 on the quay wall, taken with 700 MHz antenna. Reinforcing bars draw hyperbolas in the “radargram”. At the apex of each hyperbola is a “reinforcing bar” in transverse direction to the profile.

When interpreting these images, it must be ensured that they are not to be regarded as a direct image of the underground. For example, a highly reflective object can not only be seen vertically below the radar antenna, but it is already recorded from an oblique angle from the receiving antenna. In the “radargram” it is displayed perpendicular to the profile. This leads to the above-mentioned “bow shape” (hyperbolas). This can be seen on the “radargram” of profile F1 taken on the Quai wall: there is a regular pattern of hyperbolas (Fig.9). Four transverse reinforcing bars per meter create this pattern. The hyperbolas in the “radargram” simulate a continuous arcuate support structure, that certainly does not correspond to the reality. In fact, the “reinforcing bars” are likely to be only a few cm in width.

To correct these "artefacts" the geophysical processing method "migration" is used. This method recalculates the hyperbola branches to a circle, the actual origin of this object. However, migration only makes sense if the hyperbolas cover underlying structures or if steep structures are present. We recommend to keep the hyperbolas in the “radargram” and to analyse them. The position and depth of the object can be determined just as well without migration, because the objects are always at the vertex of the hyperbola.

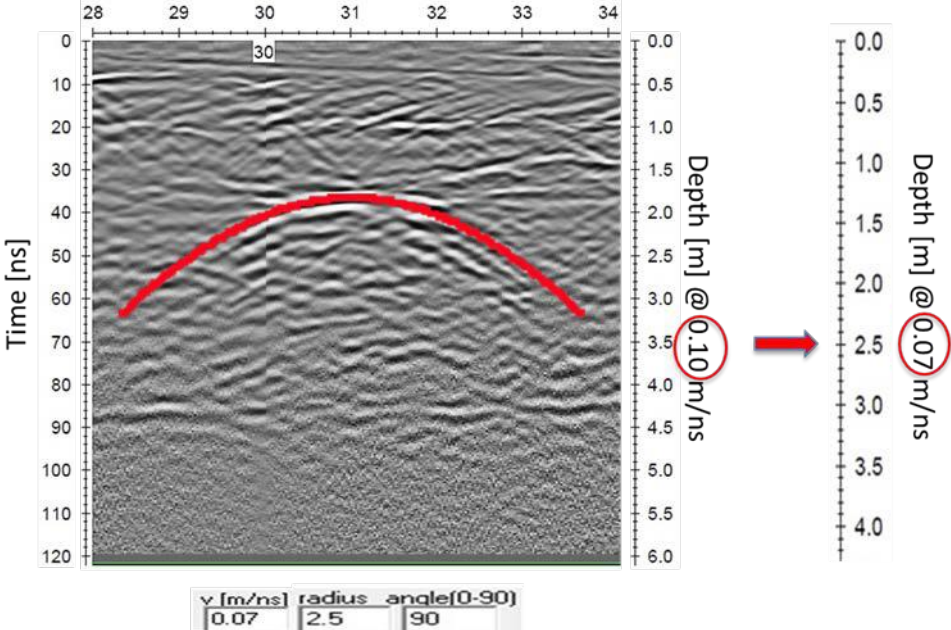
**Fig. 10):** Model hyperbola adapted to the object in Fig. 8. The depth scale on the right corresponds to the calculated speed of 0.07 m/ns adapted in the model.

The model hyperbola gives a speed of 0.07 m/ns. The depth scale must therefore be corrected at this point by a factor of 0.7. This slower speed indicates that clayey material has been deposited over the object. The model calculation of the value of the diameter of the object gave a result of 2.5 m. However, it could also be an elongated object (pipe) cut at a shallow angle. This would result in a comparable flat model hyperbola. Since the object is not seen in the neighbouring profiles, this interpretation is much more likely. A cavity washed out by the lake can thus be excluded.

As an example, the analysis of the object in 2 m depth at profile position 31 m in the radar profile F3 is shown in Fig.10.

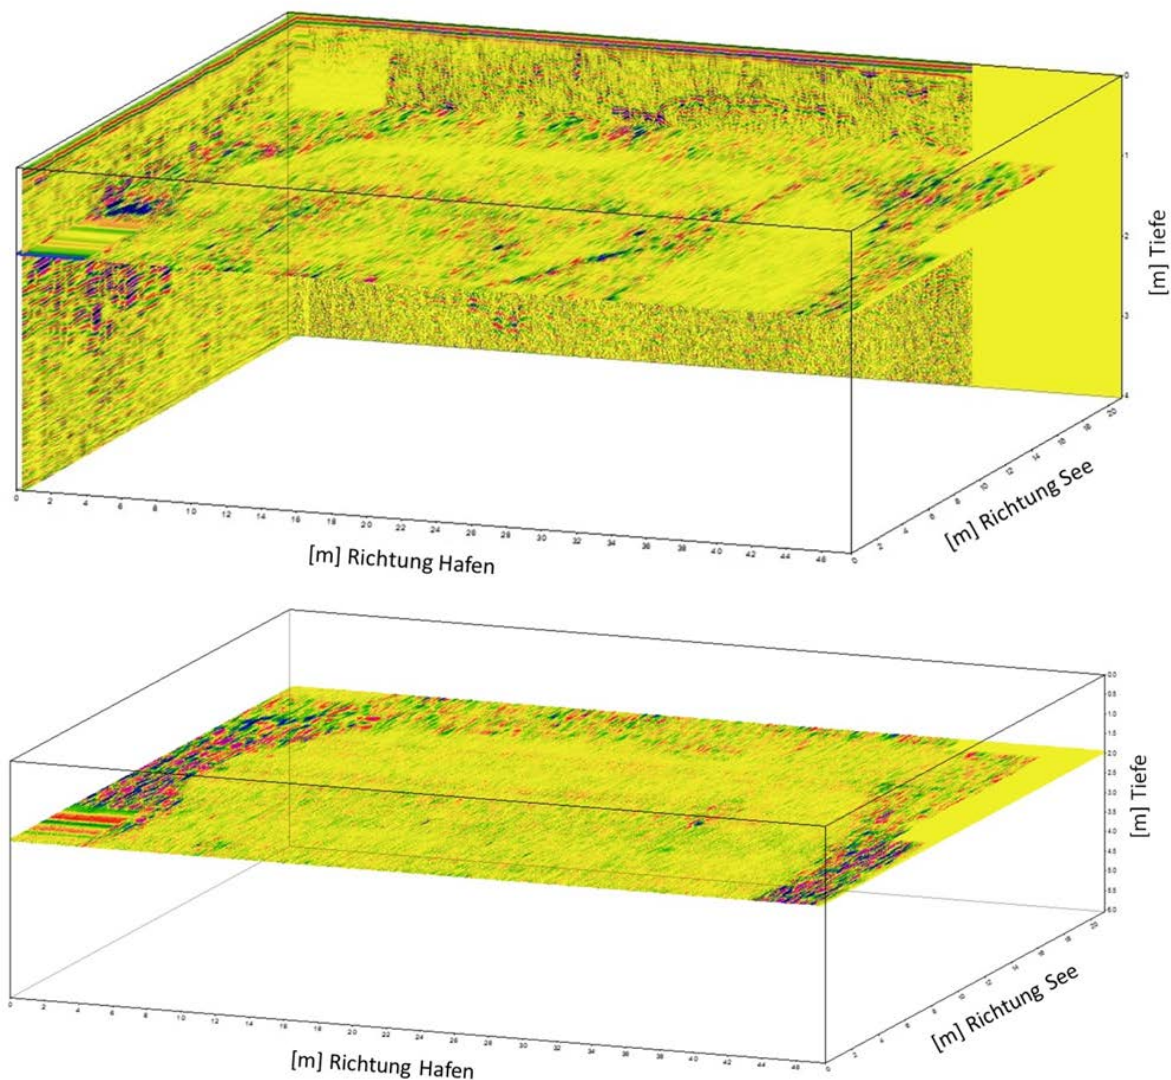
**Fig. 11):** 3-D images: In the plane view, lines are visible as a „Y-shape“ in 1.1 m depth. The lower picture shows the level at a depth of 2 m. Here, especially on the left and right side of the area, there are highly reflective zones.

The 50cm line grid recorded on the fairground plaza allows both a 3-D interpolation of the ground in the longitudinal and transverse directions as well as a plane representation with depth (see Fig. 11). These pictures are “put together” in the form of a film document. It can be played on any video player program and stopped at any depth. In the plane view, in 1.1 m depth, lines (=pipes) can be seen, which are shown as a “Y-shape”. At a depth of 2 meters you can see a dense track in the middle of the area and at the margin a deposit of landfill material is assumed, because all the area is artificially filled up. On the basis of these findings, dredging slits were executed to corroborate the interpretation.

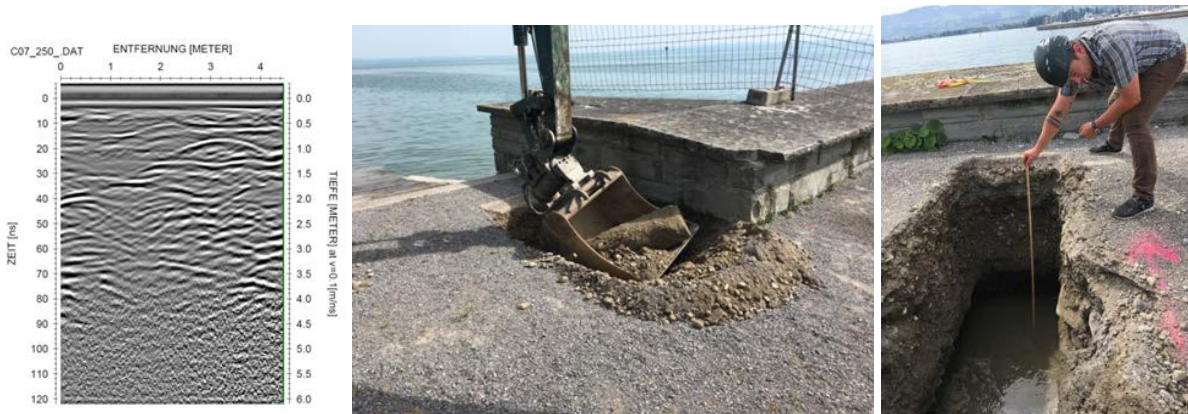
The dredging slits to the left and right of the site did not show the expected clayey landfill material. At first a large block of stone appeared, which caused the hyperbola (Fig. 12, left and center). Below the stone there followed potato-sized, round stones without finely granulated material. Water immediately flowed through the large cavities between the stones, (Fig. 12, right), which explains the change in the reflection signals at a depth of 2 meters. This shows that there is a rapid hydraulic connection to the lake water on the edge of the plaza and that a lot of fine grained material from the original fill is washed out. With great certainty it could be ruled out that the ground on the plaza would suddenly collapse. At the most, slow subsidence can occur when more fine grained material is washed out.

**Fig. 12):** The Profile C7 has a distinct hyperbola (picture left). The excavation brings out a large stone block (middle picture). The remaining excavated material consists of round stones of 3 - 5 cm diameter with little finely granulated material. The water flows immediately (picture right).
